4. A Novel Solution for Retrospective Enhancement of Passenger Vessel Damage Stability

Abstract: Ship flooding and inadequate damage stability remains the greatest risk to life in the maritime industry today. To address this problem, increasingly stringent damage stability regulations have been introduced at the international level, most recently SOLAS 2020. However, these apply only to new vessels, leaving the majority of the global fleet under older, more lenient regulations. In fact, the effect of these regulatory changes won't be fully realized for 30-40 years, when older ships are phased out, and that is a long time to wait. The challenge lies in the difficulty and cost of retrofitting older ships to meet modern standards. Adding to the problem is the tendency for the stability of vessels to deteriorate over time, meaning the situation is liable only to get worse. At the heart of the issue has been an overreliance on subdivision as the primary method of controlling flooding, which is exceedingly hard to retrofit in older ships and has diminishing returns with increased application. This highlights the need to seek alternative means of improving damage stability for both new a

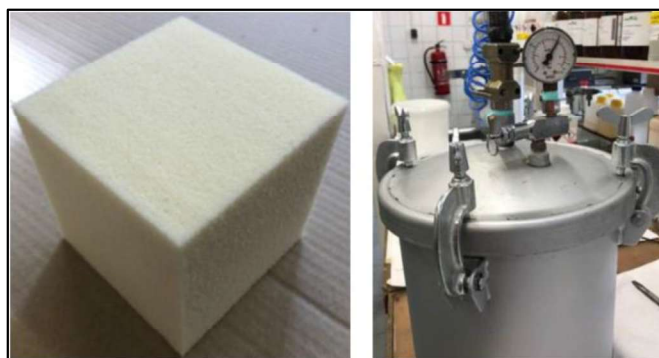
Firstly, to address the crucial question of the foam's resistance to water ingress, a series of water absorption tests were conducted. Specimens of the foam material were immersed in water, and their weight was monitored over a period of 30 days. Any detected weight increase was directly correlated to absorbed water mass, thereby allowing for the determination of the foam's permeability. Recognizing that floodwater can exert significant hydrostatic pressure on the foam mass within a damaged compartment, these tests were performed at varying external pressure, firstly at atmospheric pressure, and subsequently within a pressure vessel at 0.5 bar, 1 bar, and 1.5 bar, respectively. This comprehensive pressure regime accounts for potential water columns up to 15 meters, providing a realistic assessment of the foam's integrity under flooding conditions.

Figure 3: Foam test specimen shown left, pressure vessel shown right.

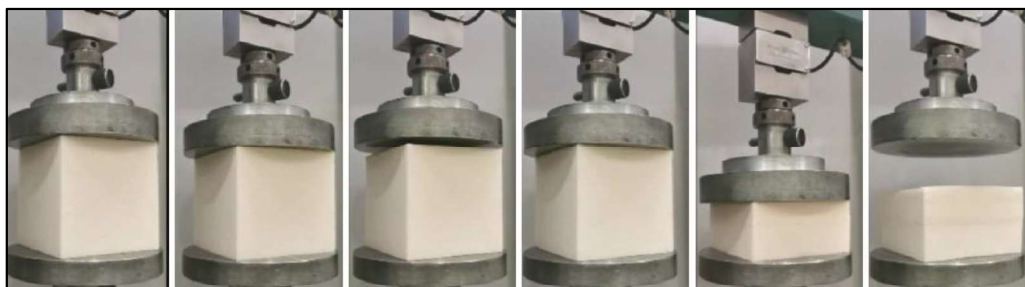
The potential for the foam to be compressed by the hydrostatic head of floodwater was investigated through compression testing, as illustrated in Figure 5. Foam specimens were subjected to axial loading in a universal testing machine to generate the material's stress-strain curve. This characterization allowed for a direct comparison between the foam's compressive strength and the expected compression forces it would experience following a flooding event, ensuring that the buoyant volume provided by the foam would not be significantly diminished under pressure.

Figure 5: Pictorial image of foam compression test

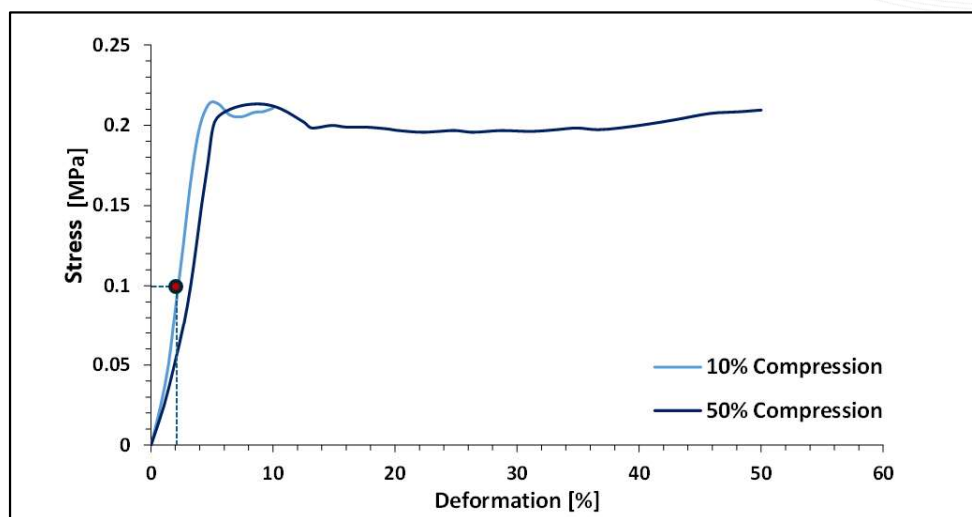
The compression tests conducted on the foam material provided critical insights into its structural integrity under simulated floodwater pressures. The results demonstrated that the elastic deformation region of the foam extends up to 0.22 MPa. Beyond this point, plastic deformation is realized, occurring at approximately 5% volumetric compression, Figure 8.

Figure 8: Foam Compressibility Results at 10% and 50% compression

Significantly, the expected compression resulting from exposure to the hydrostatic pressure in a flooding scenario is conservatively estimated at 0.1 MPa. This anticipated pressure would lead to a compression of approximately 3%. This level of compression is well within the foam's elastic range and, crucially, does not jeopardize the buoyancy offered by the foam to any

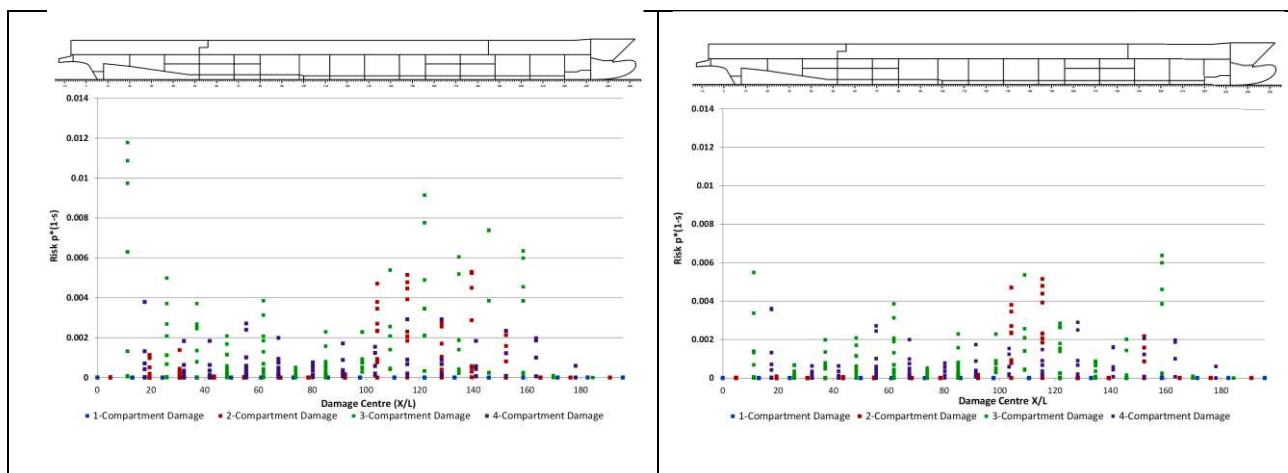
To further illustrate the profound impact of the foam solution, a side-by-side comparison of the vessel's risk profiles, both pre- and post-application of the foam, is presented in Figure 13. Here, it can be observed that the high-risk areas previously identified in the vessel's aft and fore

shoulders have undergone a significant reduction in flooding risk. In several instances, the risk has been effectively eradicated in these targeted zones. This underscores the ability of the foam solution to directly mitigate the most critical vulnerabilities within the vessel, transforming areas of high susceptibility into zones of considerably enhanced safety.

Figure 13: Comparison of Risk profiles, as built design shown left, modified design shown right
